## Incorrect Temperature Measurements: “The Importance of Transmissivity and Infrared Windows”

### **Official Report Excerpt: Summer 2009**

At approximately 9:30AM on Monday morning, I began the quarterly inspection of the plants main switch gear (23KV incoming line, distribution switches). All Inspections on the main switch gear were made via 3 inch Calcium Fluoride (CaF<sub>2</sub>) Crystal Infrared Viewing Panes. The Imager used was a FLIR 695 with standard Emissivity set at 0.92.

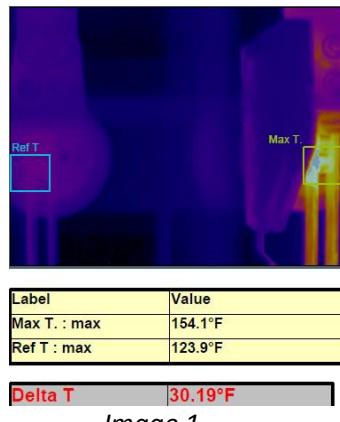
I reported the following to the PM: Isolation switch number one (Switch# 1) has a 30°F ΔT on the “C” phase Disconnect contact.

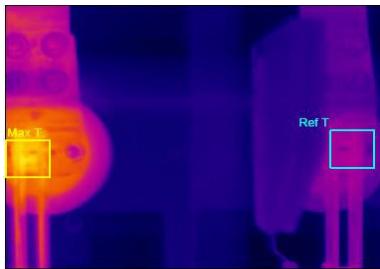
Image 2

Isolation Switch Number Two (Switch 2) has two hot spots: the first anomaly (21 °F ΔT) on the Phase “A” Disconnect contact (Image 2). The second anomaly (30°F ΔT) on the phase “C” Disconnect contact (Image 1).

Label	Value
Max T. : max	146.0°F
Ref T : max	124.8°F

Delta T **21.19°F**

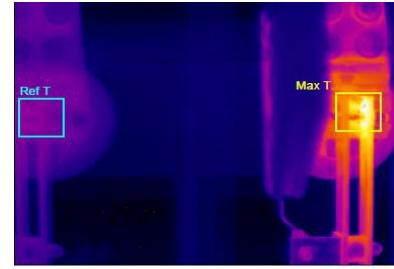
Image 3

Label	Value
Max T. : max	146.9°F
Ref T : max	117.3°F

Delta T **29.51°F**

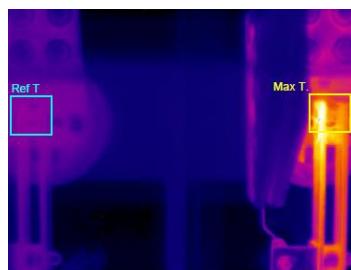
Image 4

Back on site Wednesday morning, I performed a complete scan of all incoming line switchgear. Though all anomalies were still present, I found that switch #1's anomaly had doubled to  $>60^{\circ}\text{F } \Delta\text{T}$ !

Label	Value
Max T. : max	179.6°F
Ref T : max	119.1°F

Delta T **60.54°F**

A quick look at the production rate verified that the loading of the switch had not increased. Once again I generated a report and notified the PM. The Utility Company was contacted but not receptive.

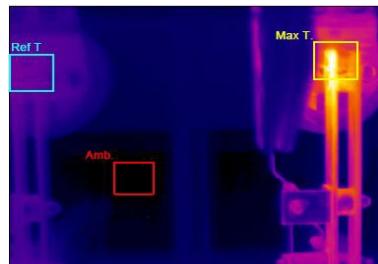
Image 5

The next morning, Thursday, I came in early and scanned the equipment before sunrise. I found and reported that Switch No. 1 had increased to nearly 75°F ΔT. (Image 5) This anomaly had risen 150% in just 3 days!

Label	Value
Max T. : max	211.2°F
Ref T : max	137.4°F
Amb. : max	118.6°F
<b>Delta T</b>	<b>73.73°F</b>

I captured the images and send out the report. In less than an hour a meeting was held. Reports were sent, calls were made, and the corporate office got involved. Management ordered a decrease in the production rate immediately. No one was willing to let a 75°F ΔT remain in the Incoming Power switch that fed half of the plant. Not on their watch.

The plan was to take Switch #1 offline during a 2 hour power outage that evening. As is sometimes the case, paperwork and part acquisition delayed the repair. Finally, the switch was thrown around 2:00AM Friday morning.

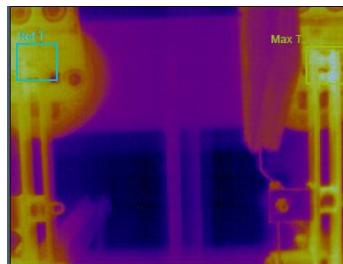
Image 6

I arrived on site Friday morning just as the electricians were clearing locks and tags and preparing to bring the switch back on line. After the switch was loaded, I scanned the anomaly and reported that Switch #1 appeared to have no hot spots. Repairs, though costly, were successful.

Label	Value
Max T. : max	110.9°F
Ref T : max	110.0°F
<b>Delta T</b>	<b>0.92°F</b>

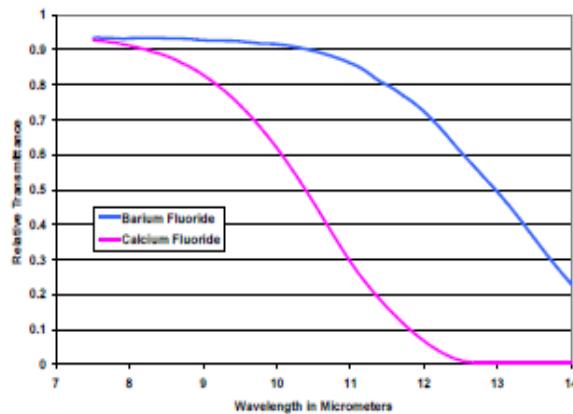
According to the report, transmission rates are typically variable across the infrared spectrum (as shown in Madding, 2004 1), yet the manufacturer's specified transmission rate is generally relevant for a specific wavelength. So, while a Crystal may indeed have a 95% transmission rate in the short wave, most industrial IR camera operate in the long-(mid) wave or 8-14 μm.

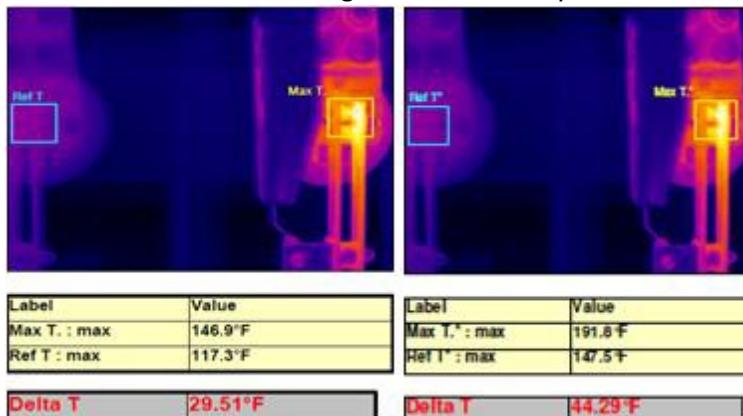
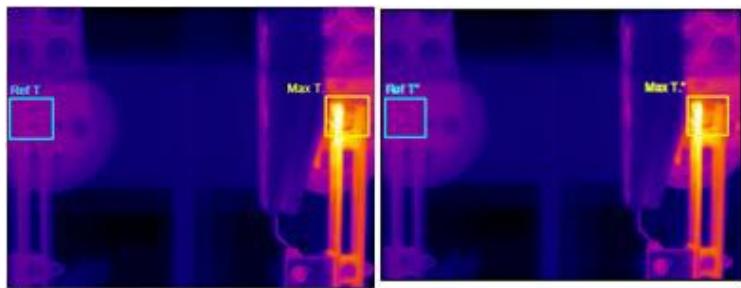
Using the imager’s software, I was able to change the flawed temperature readings I had collected by inputting the correction of .55 Emissivity. The results confirmed the “coffee cup test” and the fact that I had erred in my original calculations. Thermography software as well as many cameras themselves also provides a way to correct for transmission losses. For additional tips contact your window or camera manufacturer. Additional tips can also be found at <http://www.iriss.com>

Below are the switch #1 images after Emissivity correction.

Label	Value
Max T. : max	179.6°F
Ref T : max	119.1°F

Label	Value
Max T.': max	239.7°F
Ref T.': max	150.2°F

Delta T **60.54°F**

Delta T **89.52°F**

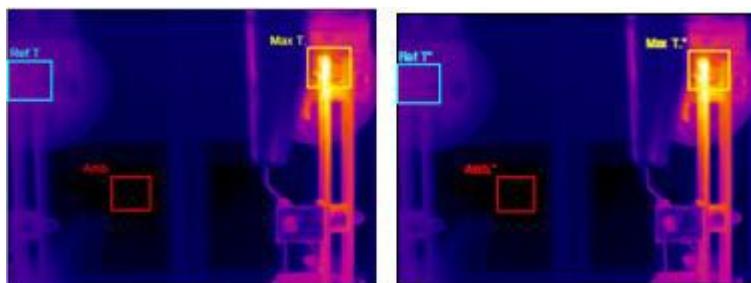
Label	Value
Max T. : max	211.2°F
Ref T. : max	137.4°F
Amb. : max	118.6°F
Delta T	<b>73.73°F</b>

Label	Value
Max T.': max	285.1°F
Ref T.': max	177.8°F
Amb.': max	149.4°F
Delta T	<b>107.24°F</b>
